ASUS M930 Level 3 4 Trouble shooting Guide

Ver 1.0

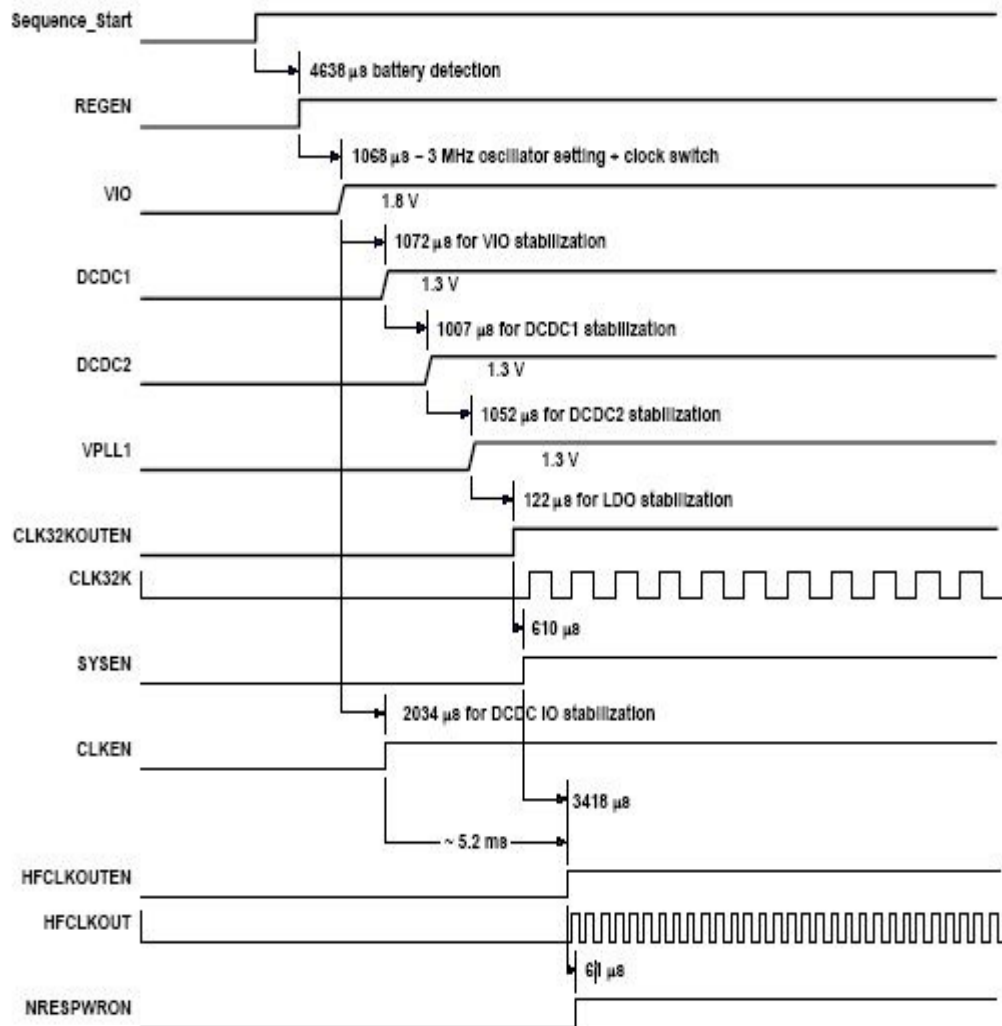
Figure 3. Power On Sequence

The VBAT can make sure the system power effective. Please check the voltage on the CON23 pin1.

The signal V_{CORE} and V_{IO} can make sure cpu power domain from PMU. Please check the voltage and try to eliminate component soldering issue (cold soldering, float mounting) on the below item:

R77 、 R19 / R202 、 R76 、 R72

Please check the voltage and try to eliminate component soldering issue (cold soldering, float mounting) on the below item:

R20.

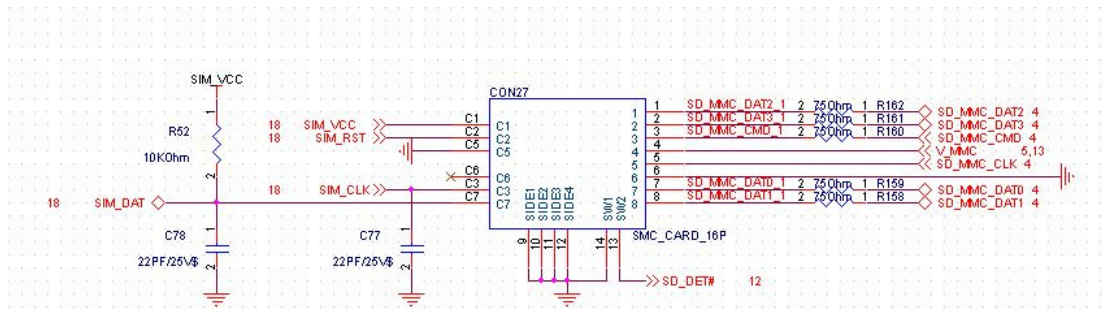
Figure 6. MicroSD + SIM Circuit

- A. V_MMC 3.0V, CON27 Pin4
- B. SD_DET# 0V, R54 Pin1.
- C.

If item A fail, try to check open or short issue on the PMU.

If item B fail, try to check the CON27 Pin13 & Pin14. In the general; it will short when we put in the card. Please change the CON27 if the Pin13 and Pin 14 not short.

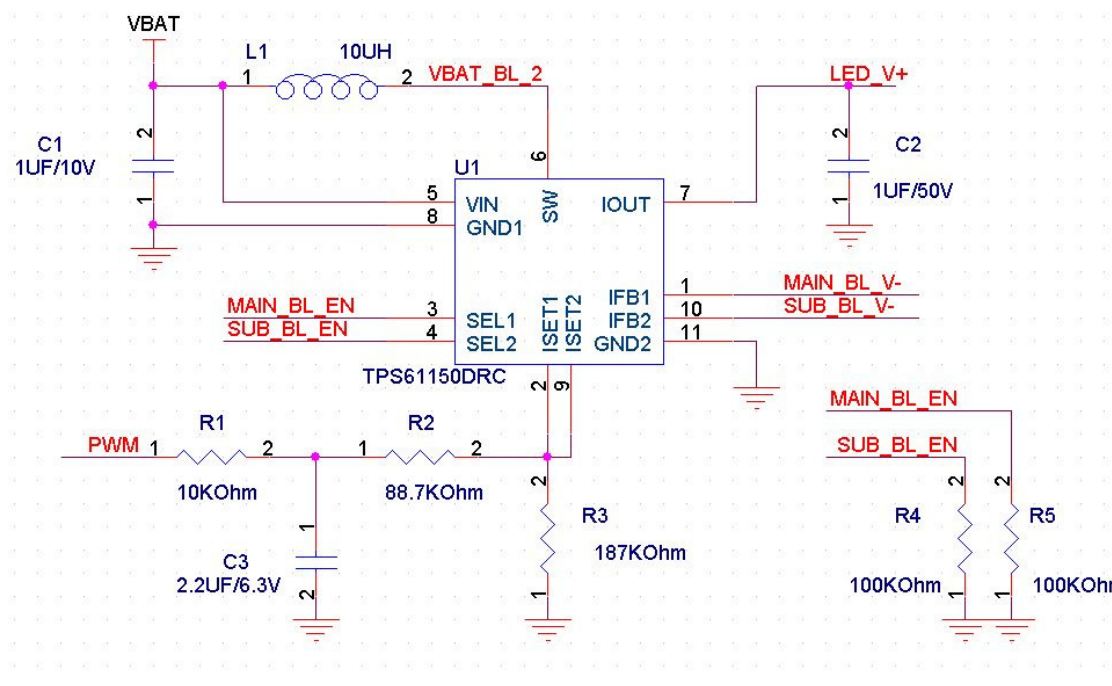
Figure 7. Backlight Driver Circuit (On LCD_PCB board)

- A. VIO_LCD 1.8V,
R143 both side.
- B. LCD_VSYNC
LCD_HSYNC
LCD_PCLK video clock,
C238Pin1、C239Pin1、R111 both side on soldering issue.
- C. If the main screen backlight wasn't executed, we can check below items on the LCD_PCB auxiliary board.
(LED_V+) 12.1V
MAIN_BL_EN 1.8V

- D. If the secondary screen backlight wasn't executed, we can check below items on the LCD_PCB auxiliary board.
LED_V+ 6.2V
SUB_BL_EN 1.8V

If something wrong with the result which we found, please check U1 peripheral components and circuit.

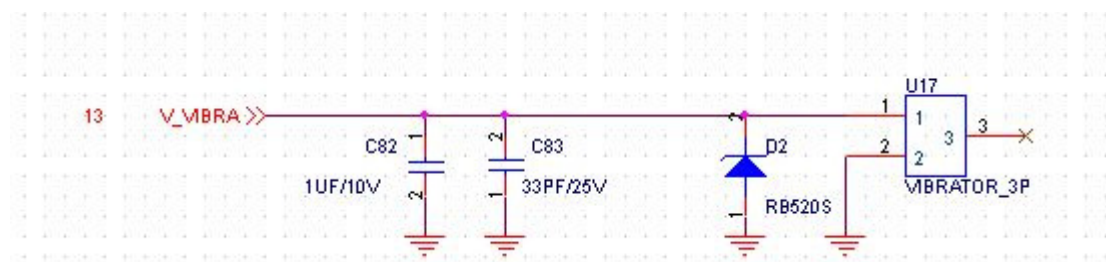
Figure 8. Vibrator Circuit

U17 Pin1	3.0V
PMU (U31)	open / short

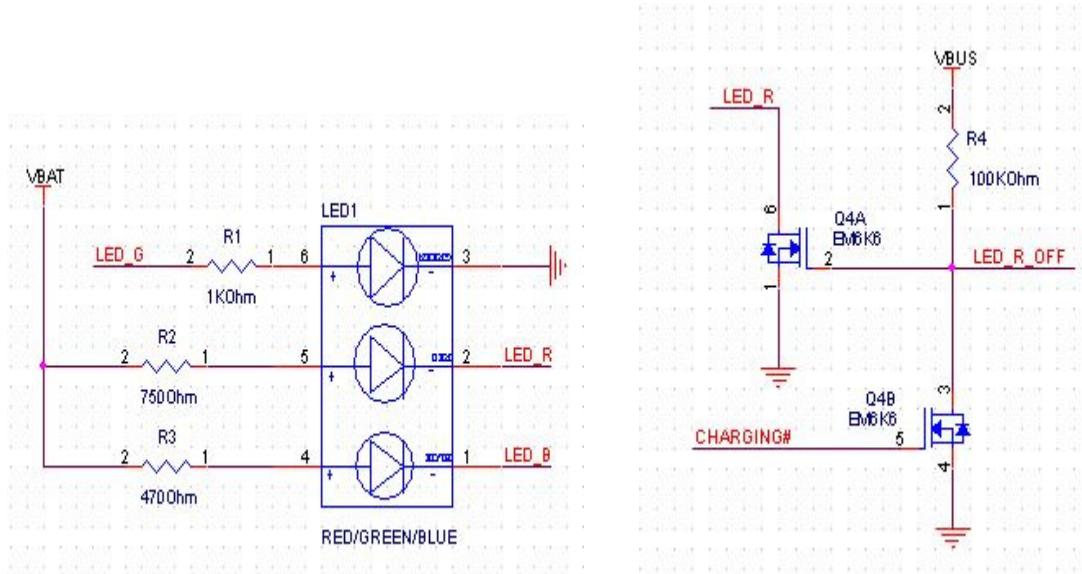
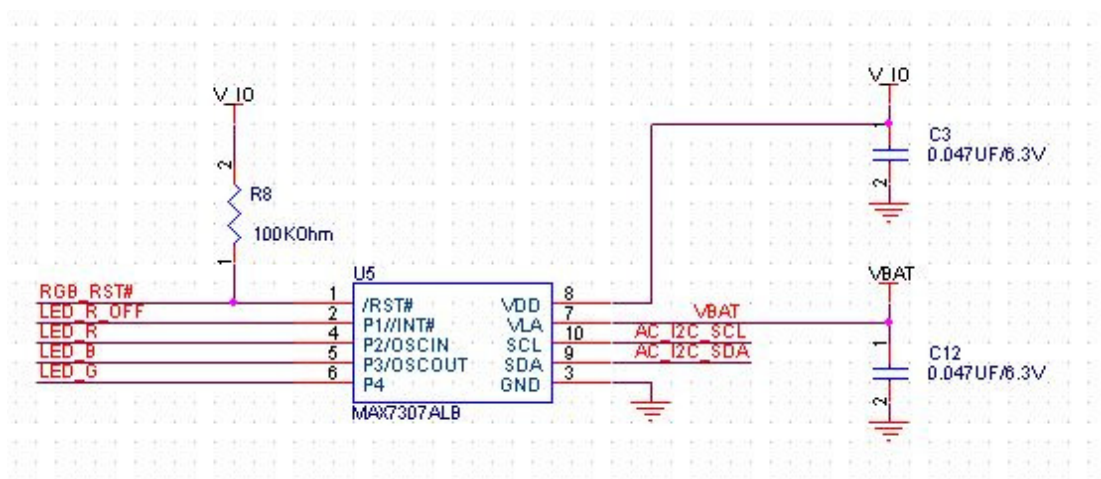
1. Please check R1, R2, R3 on soldering status.
2. Check the Pin9 and Pin 10 on the U5.
3. If the answer is no, please check the open/short on the CPU.
4. Replace the LED1.

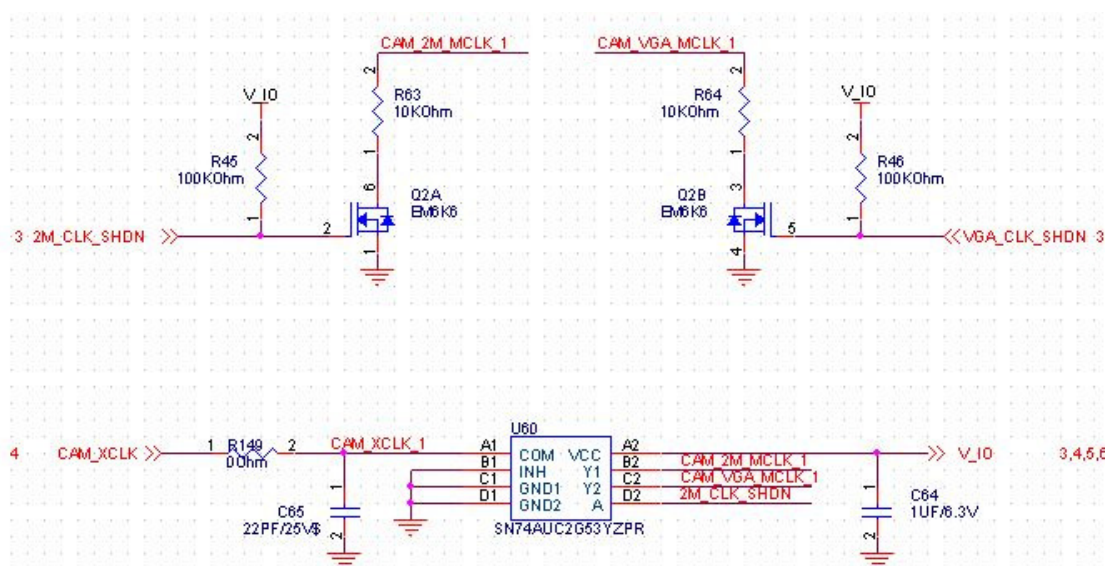
Figure 11. Camera control signal

We also test the item after assembly process. The main reason of the defective will focus on camera. Ex. Camera FPC fail 、 lens of the camera dirty 、 can't focus. If the pre-view image also shacking on the screen. Please check the defective or damage on the Coaxial Cable and follow procedure.

- i. VCAM_2V8 2.8V, C69 Pin1.If not please check the PMU.

- ii. V_IO 1.8V, CON2 Pin6
- iii. 2M camera and VGA common signal bus
KEY_I2C_SCL、KEY_I2C_SDA、CAM_D0~D7
- iv. 2M Camera ON
CAM_2M_MCLK and CAM_XCLK Clock
2M_CLK_SHDN Low
VGA_CLK_SHDN High
- v. VGA Camera ON
CAM_VGA_MCLK and CAM_XCLK Clock
2M_CLK_SHDN High
VGA_CLK_SHDN Low

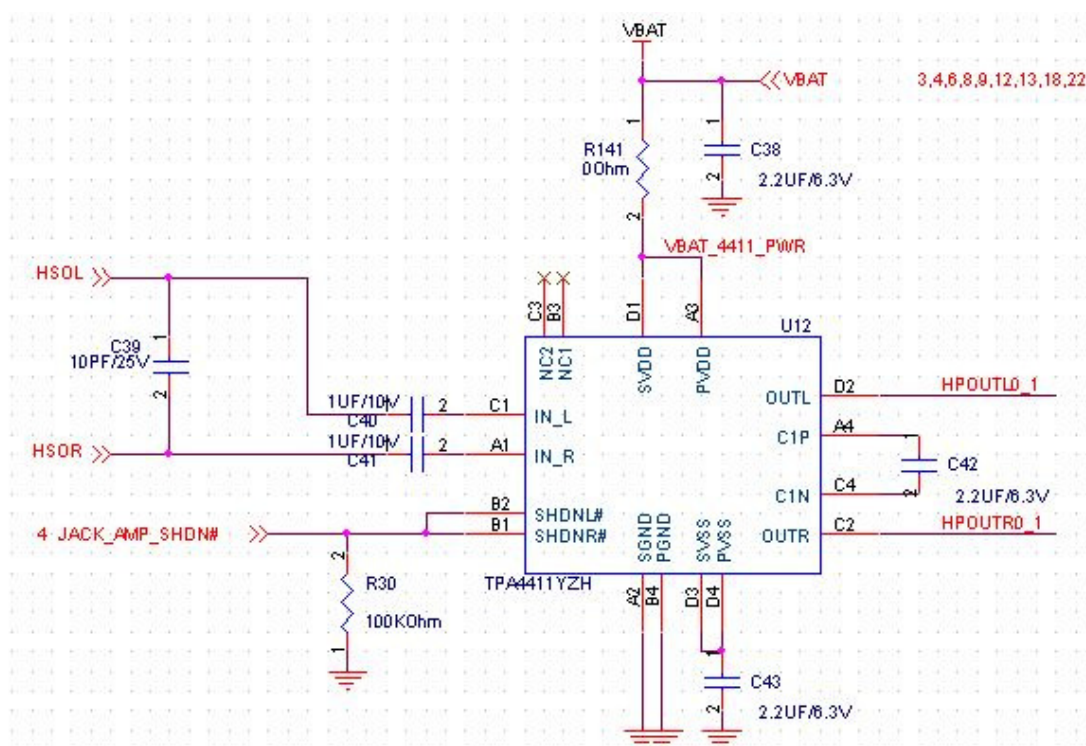
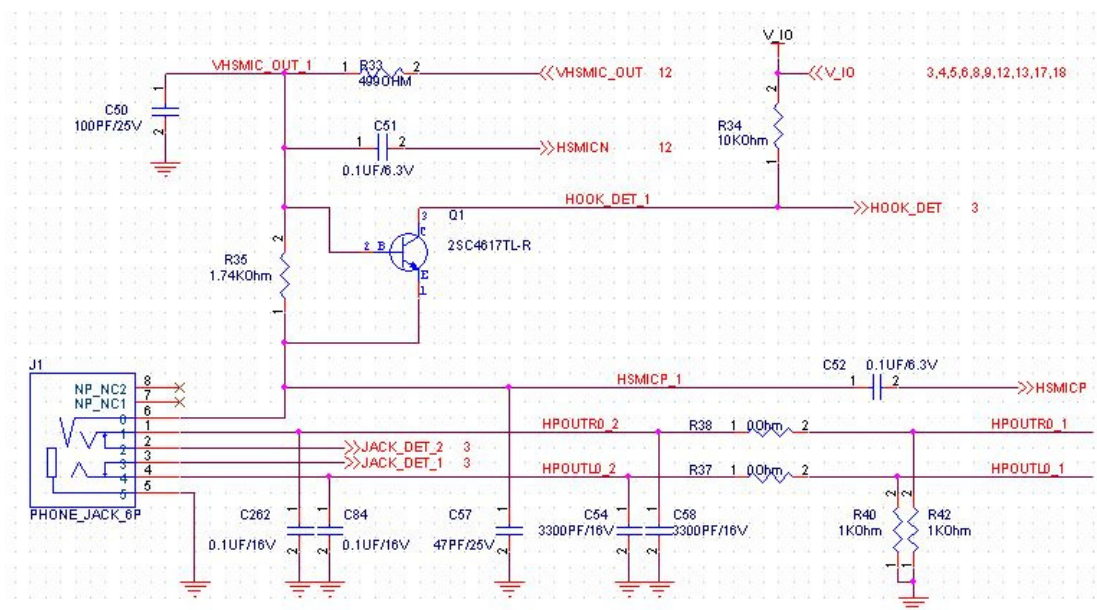
- If headset signal can't be detected by phone. Please check the , JACK_DET_1 and JACK_DET_2 1.8V. Please check the below components: R36、R93、C56、C240.

Please check the related circuit on U12, , ex: C40、C41、R37、R38 both side to avoid soldering issue. Check the R30 Pin2 → 是高 (1.8V)

Please check the signal from HSMICP and HSMICN, Please check the related component on soldering issue. ex. C51、C52、R35.

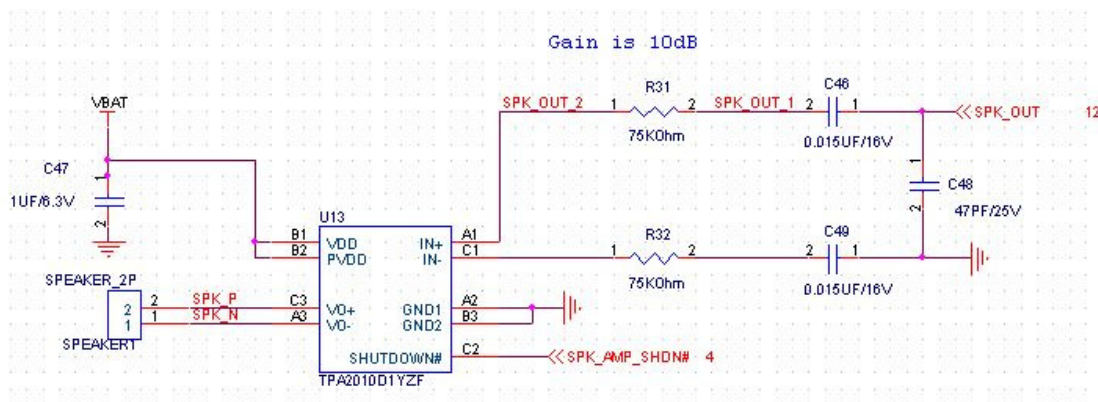
Figure 14. Class D Amp for speaker

R31 、 R32 Audio signal (oscillate scope)

C46 、 C49 Audio signal (oscillate scope)

If the C46 、 C49 can be check signal but SPK_P 、 SPK_N no be measured, please replace the U13 (Class-D Amp).

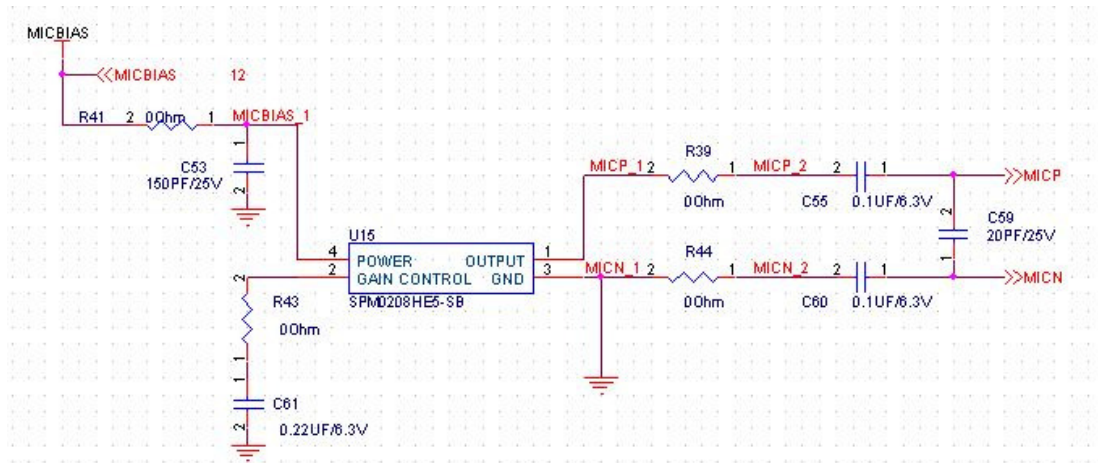
Figure 15. Microphone circuit

If recording quality is poor → U15 NG.

If recording function is fail, please check R39、R44、C55、C60.

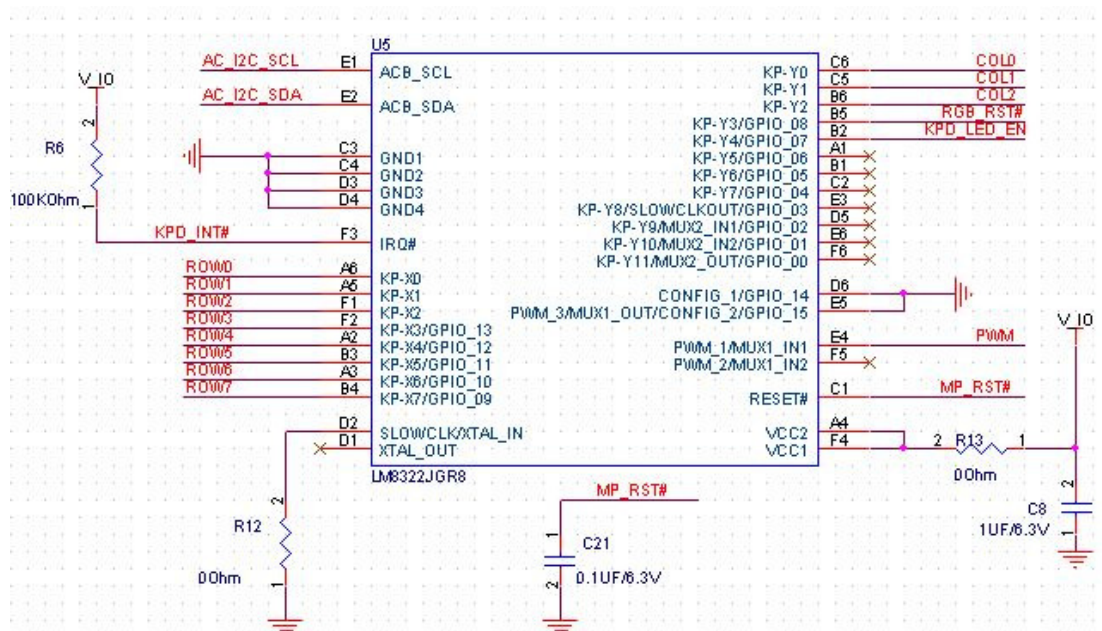
Figure 16. Keypad controller circuit(On LCD_PCB board)

We will use those functions on the U5 I/O controller IC from LCD_PCB. If you can feel the button has pushed after the function can not executed. Please check the signal **KPD_INT#** and the signal of the U5 by oscillate scope.

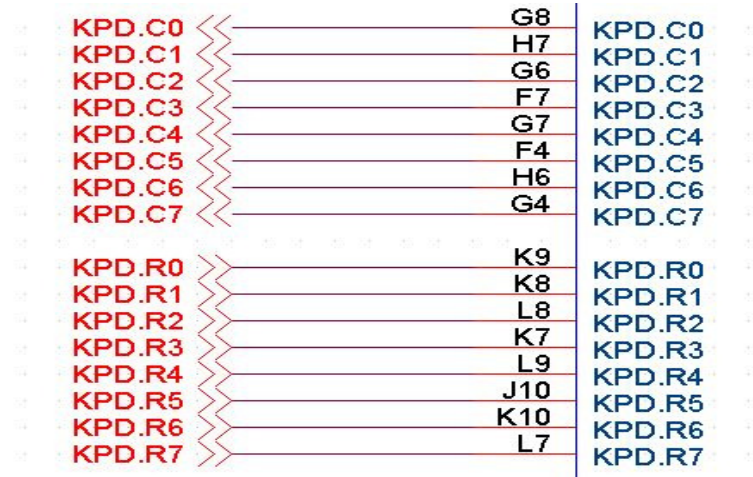
Figure 17. Qwerty Keypad controller circuit

The signal control by U31. If you have any problem, try to check soldering issue(Open / Short) by X-ray.

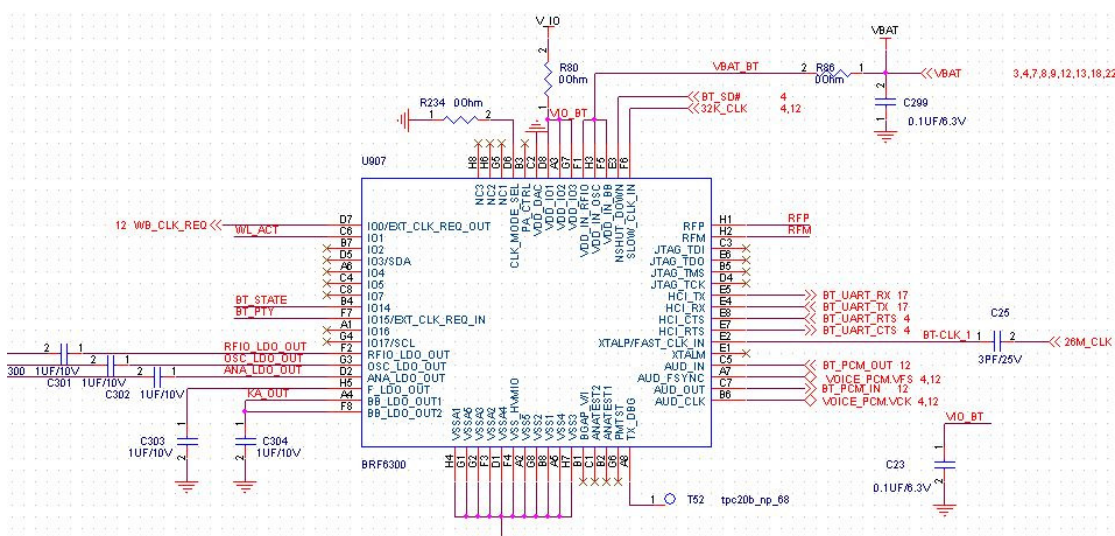
Figure 18. BT circuit

Check	C25	26MHz clock
Visual inspection	R80、R86	
Check	U55 Pin1	Low
Pin9/Pin10	Short	
Pin6/Pin7	Short

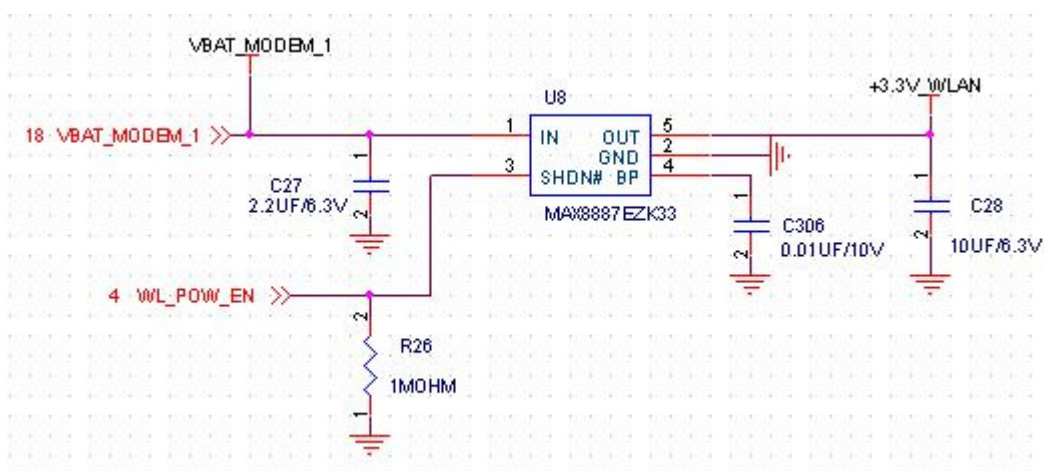
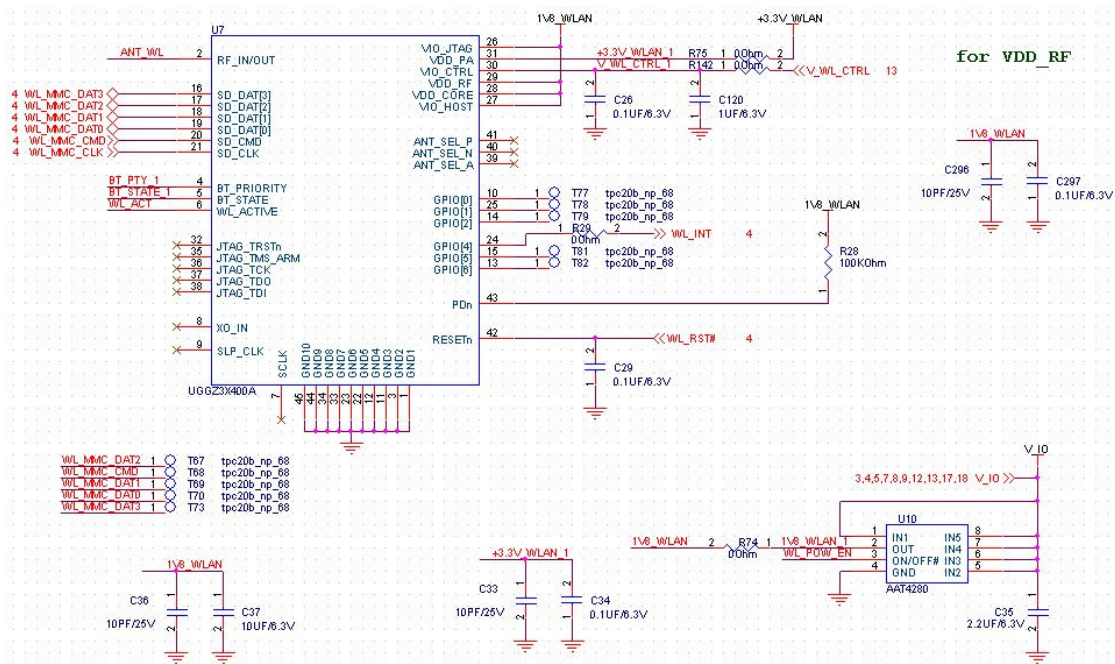
- D. Check R74 1.8V
- E. Check U10 Pin3 1.8V (High), If the result is true please check the U10 on the soldering issue.
- F. Check U8 Pin3 1.8V (High)
Pin5 3.3V
- G. Check the signal of the R29 will get the dynamic wave by oscillate scope.
- H. Check R75 3.3V
R142 2.85V

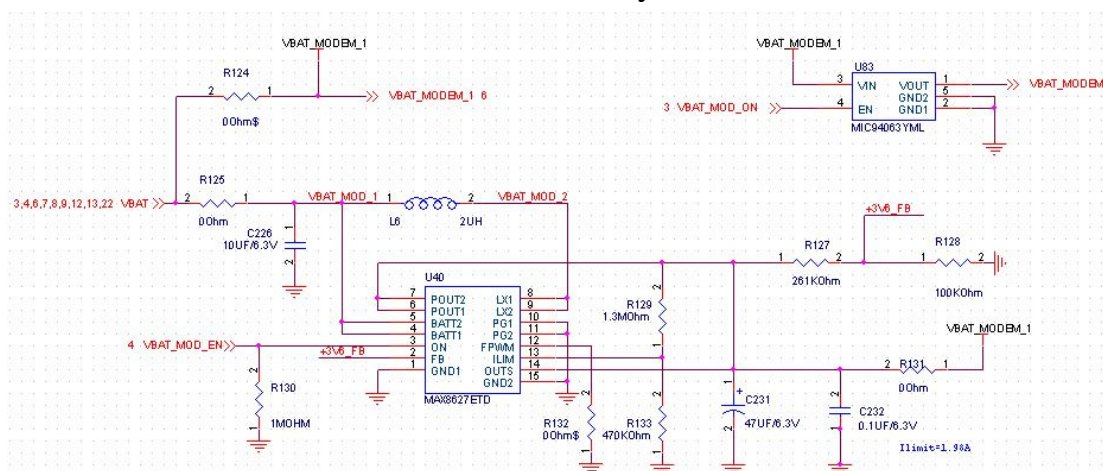
Figure 22. Modem Power circuit

1. VBAT_MODEM 3.6V ~ 4.2V
2. VBAT_MODEM_1 3.6V ~ 4.2V
3. VBAT_MOD_EN 1.8V(High)
4. Check the schematic related of the U40, try to rework with the U40.

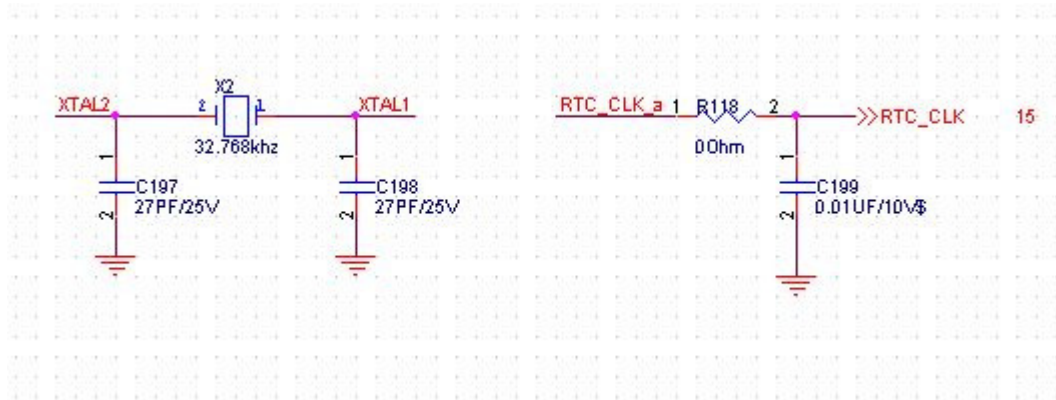
Figure 23. Modem RTC circuit

5. VDDD_1V5 1.5V
- VDDE_1V8 1.8V
- VDDC_2V75 2.75V
6. MOD_POW_ON 1.8V(?)
7. RTC_CLK 32.768 KHz Clock
8. If Item5~7 will Ok, please replace the U39 to improve the condition.

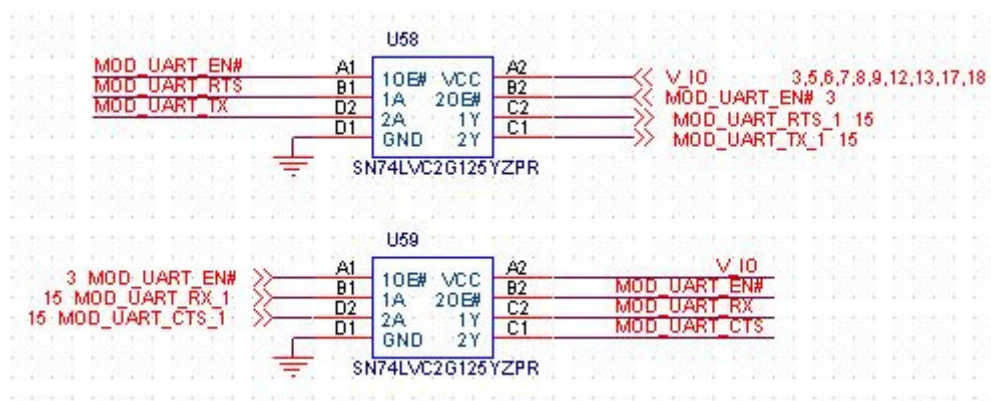
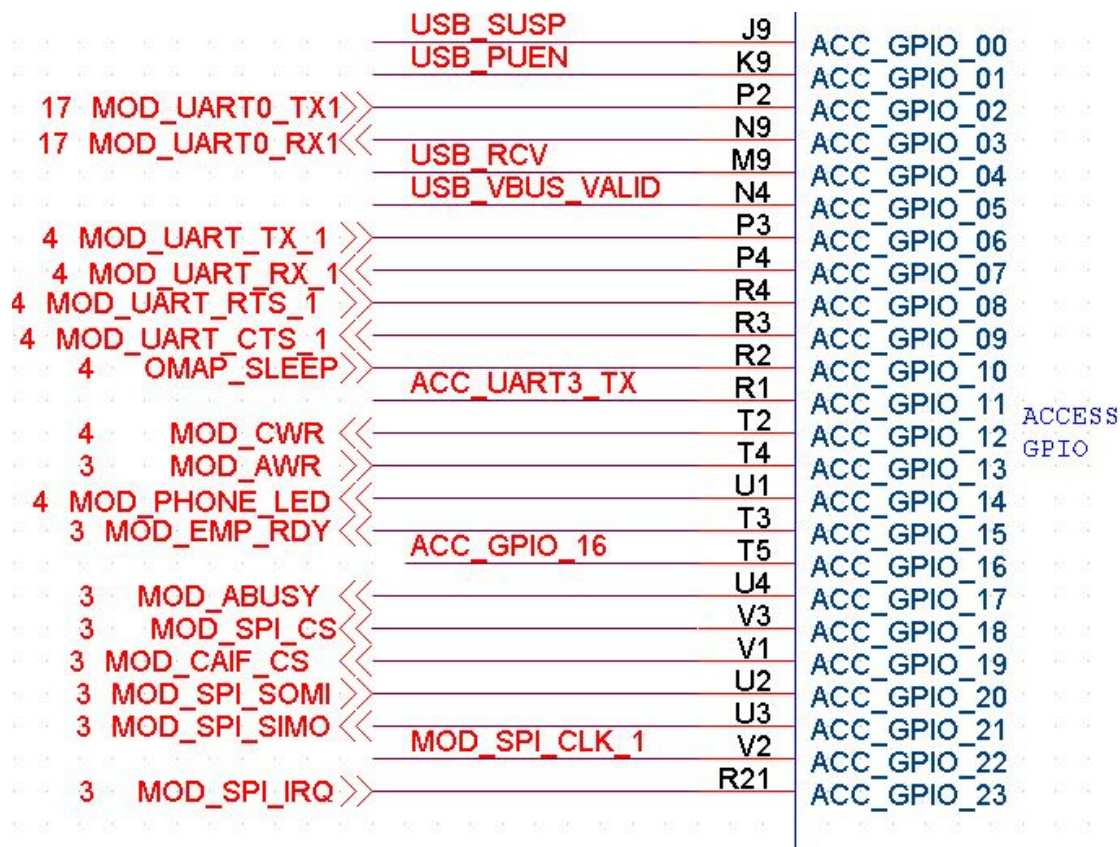
The main inter phase which connected from CPU and Modem is constructed by U58 and U59. Please check the soldering condition on the BGA package of the chips(U58 、U59) by X-ray detection.
